COMMUNITY ALERT

PROPANE CYLINDER FAILURE POTENTIAL

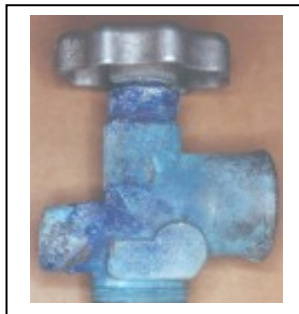
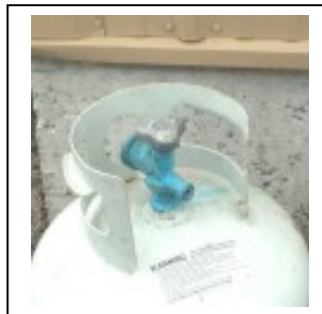
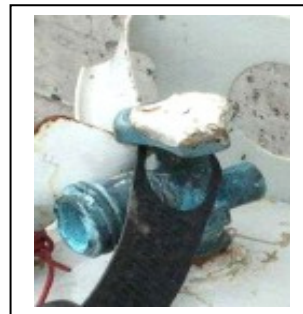
Be on the look-out for **propane gas cylinders that have a blue or greenish residue or corrosion** appearance on and around the neck of the valve assembly. This discoloration could be a sign that the cylinder once contained a corrosive gas called Anhydrous Ammonia (used in the illegal and dangerous production of methamphetamine).

Anhydrous ammonia is very corrosive and weakens the structure of the tank. The blue or green residue and corrosion becomes evident around the neck and valve as does the un-mistakable pungent odour of ammonia.

The drug producers return the weakened cylinder to the exchange and purchase a new cylinder. This deterioration will lead to cracking of the valve body or its components and can ultimately result in a violent, unexpected expulsion of the valve from the cylinder, causing personal injury or death.

These cylinder valves show the signs of corrosion and damage that can be the direct result of them having contained Anhydrous Ammonia at some point.

Vendors: Do not take back any cylinders that show these signs. Report this to us immediately.

Consumers: Do not buy or use any cylinders that show these signs. Report your suspicion to the vendor immediately, who should immediately call police and fire services.

Do not buy, accept, fill, use or handle tanks that exhibit these characteristics.
